BUILDING COMMUNITY

UTVÁŘENÍ OBCE - MORAVSKÁ NOVÁ VES

Ewen Cloirec
DESIGN STUDIO 2M
Arch. Marco Bruno Andrade Maio | Ing. arch Adam Bohatý
SUMMER SEMESTR 2021/2022 A+S Fsv CTU in Prague

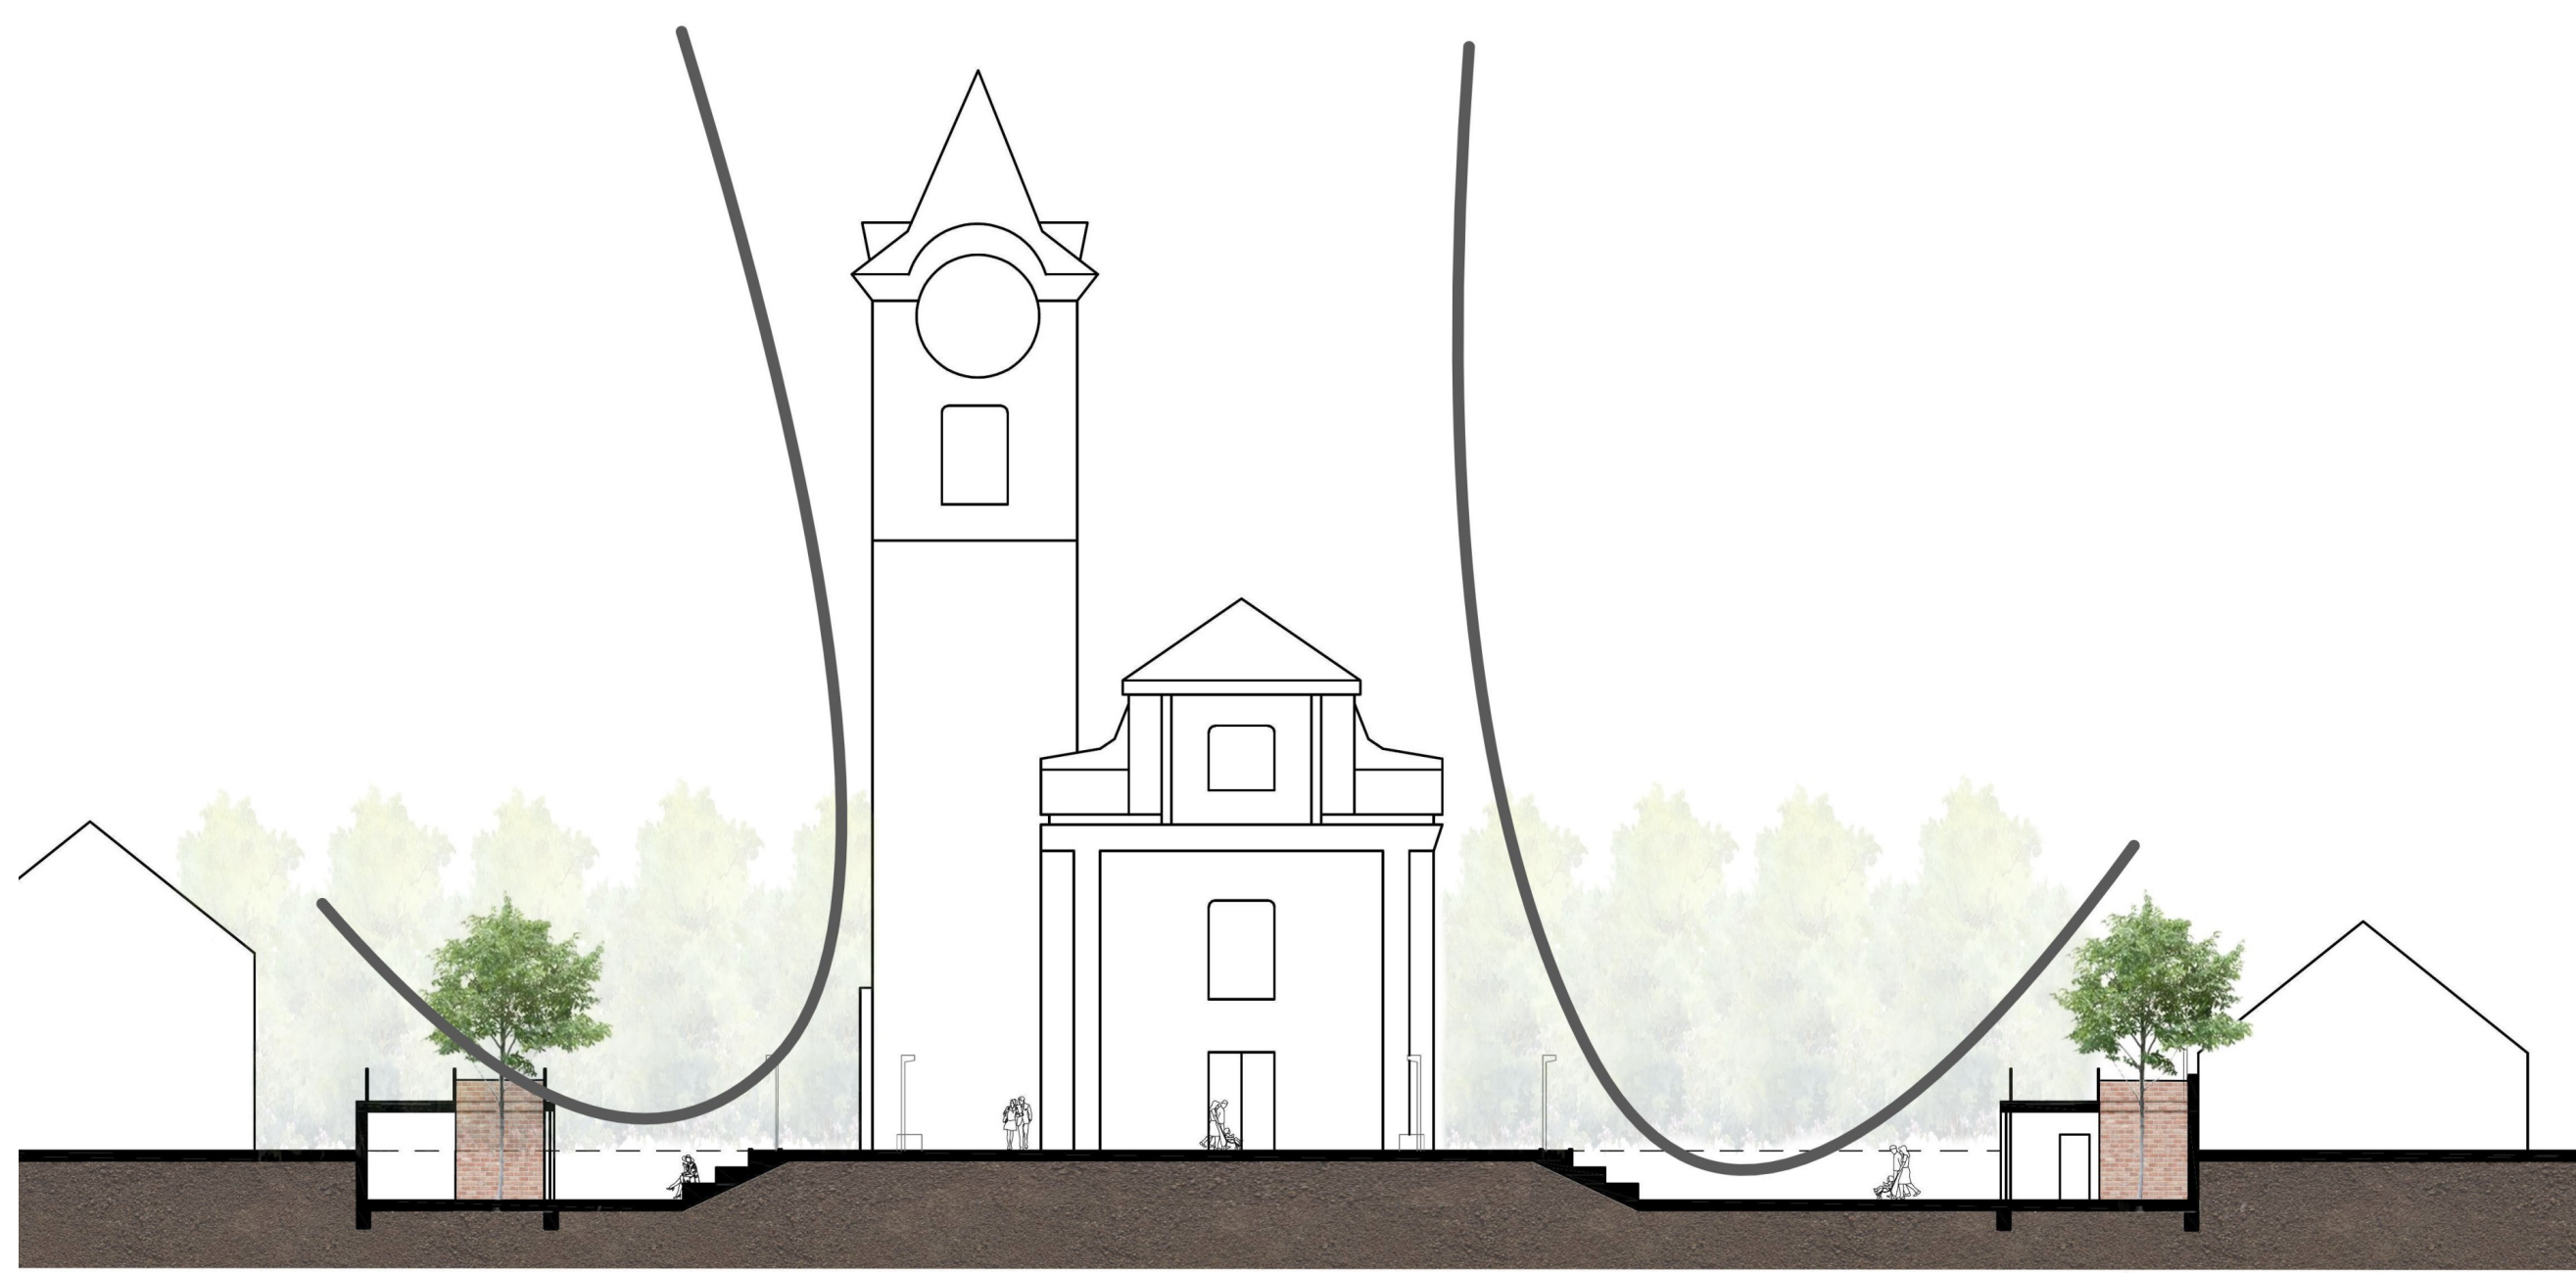
Section A-A

The principle of my concept is to have 2 areas around the church that would be 1.5m down. As well as emphasizing the verticality of the church, these 2 areas will create a feeling of community. Indeed, thanks to the stairs all around, people can sit, read a book, chat with friends or drink coffee and wine. Here could happen any community event, and it will be up to the community to make it live. I used bricks for the façade and beige pavement for the outdoor places, in front of the church and in front of the Town Hall.

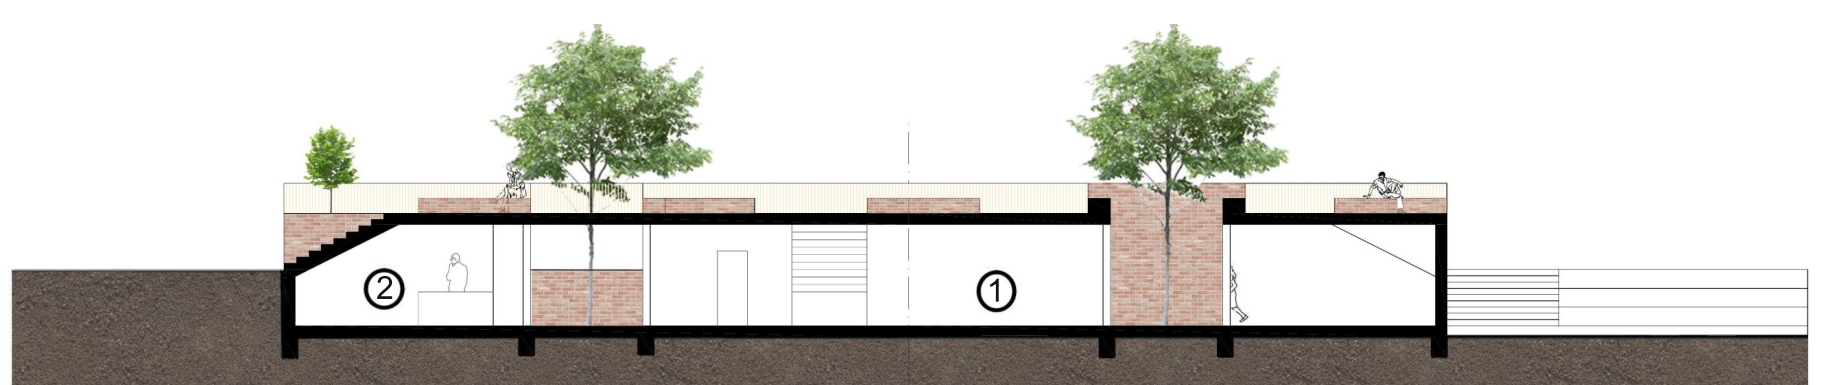
Section B-B Community Center Building 1

Roof Path 1.5m
Earth level 0.0m
Ground Floor -1.5m

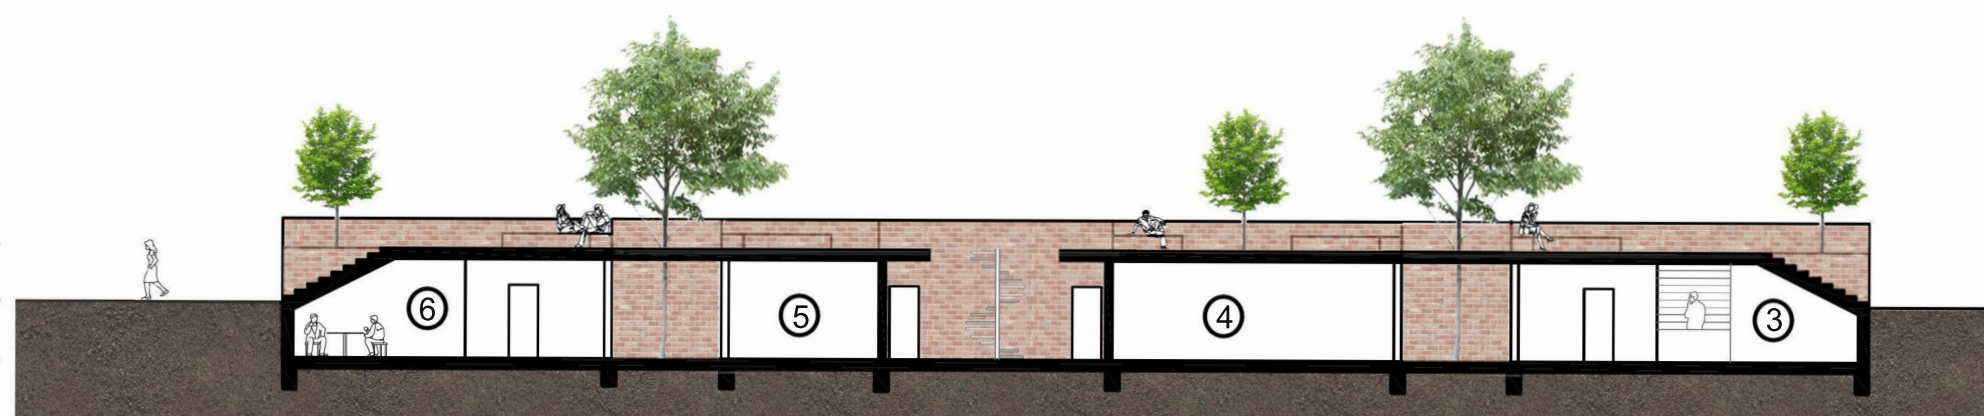
Section C-C Community Center Building 2

Roof Path 1.5m
Earth level 0.0m
Ground Floor -1.5m
